# **Littoral Marsh Enhancement**

## **Northwest Marsh and Burnt Bridge / Lake Okeechobee**

## **Lake Okeechobee Dyess Ditch Marsh Flow-Way**

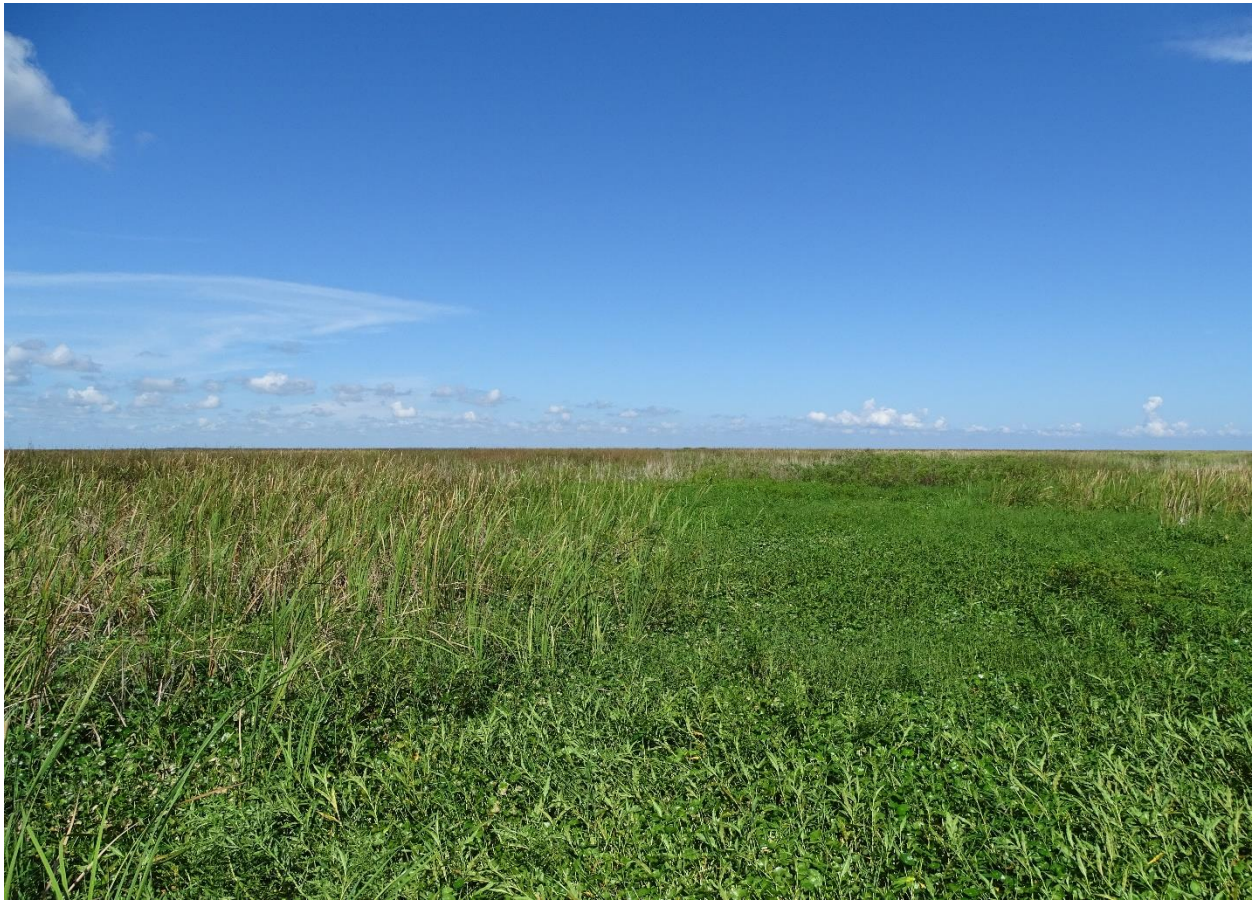
Burnt-Out Bridge Project Site

**Figure 2.- Proposed treatment area of the Burnt-Out Bridge area (134 acres). Project is expected to enhance the littoral marsh west of the Burnt Bridge area by recolonization of native emergent and submersed species and restore flow-ways for wave energy through the Burnt Bridge area.**

This project area lies between Kreamer and Torry Islands in the south end of Lake Okeechobee and is approximately 134 acres (Figure 2). Over time, this area has become thick and overgrown with cattail, Carolina willow, and *Phragmites* reducing its value to fish and wildlife, hunters, fisherman, birdwatchers, and boaters alike. The project area extends from the Burn-Out Bridge area northwest to the open water of the lake.

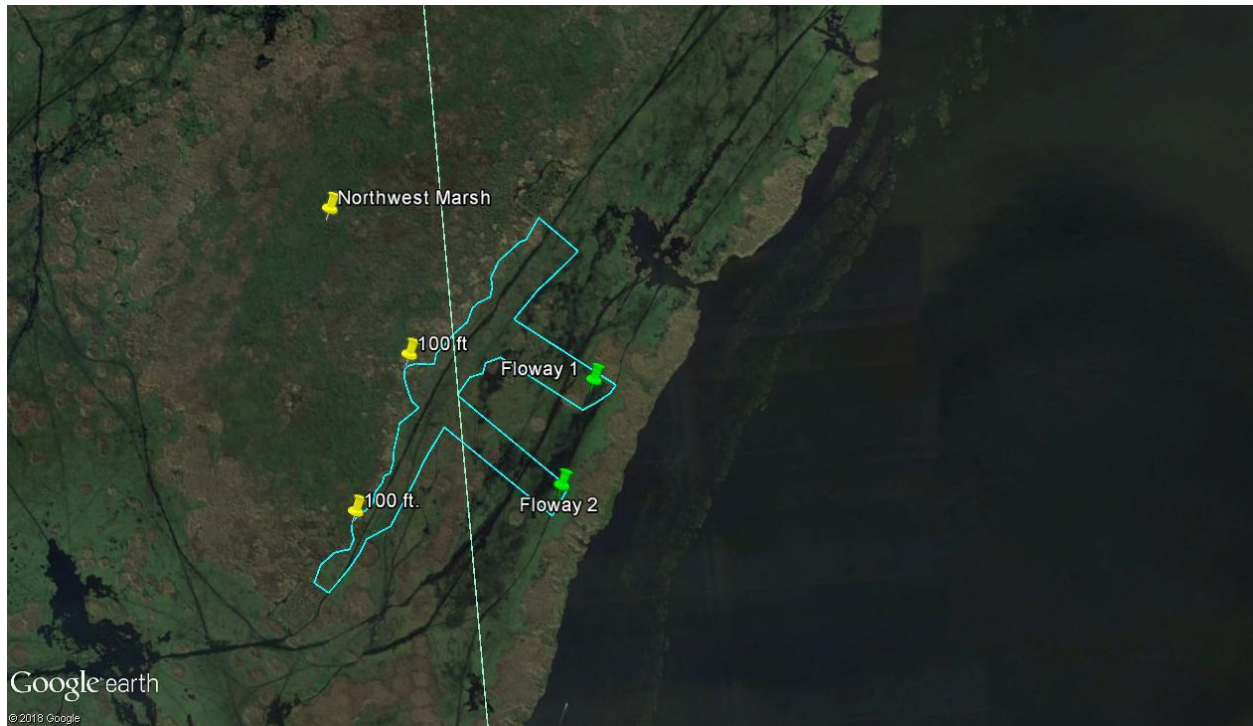
**Figure 1. – Proposed treatment area of the Northwest Marsh (70 acres). Project is expected to disperse the organic material.**

**Project Objective:** The objective of this project is to shred 70-acres of organic berm in the northwest marsh. By using four different opening techniques along the berm, we can evaluate what technique will best disperse the shredded organic berm (Figure 1). This project is necessary to develop a mechanism that will allow for maintenance of the 2001 scrape project. If this project is successful, we may use these management strategies in other locations along the northwest marsh where the organic berm has formed. If these techniques do not work, then lake the lake will need to be low enough (likely under 10 feet) to bring heavy equipment into the site to mechanically remove the built-up organics. The project area will be allowed to naturally recolonize with native vegetation.

1. One cut will extend from the organic berm towards the lake.
2. One semi-circular cut will extend from the organic berm towards the cattail wall (towards the levee).
3. One cut extending from the organic berm towards the lake with an additional semi-circular cut on the opposite side extending from the organic berm towards the cattail wall.
4. No additional cuts, just the berm will be shredded.

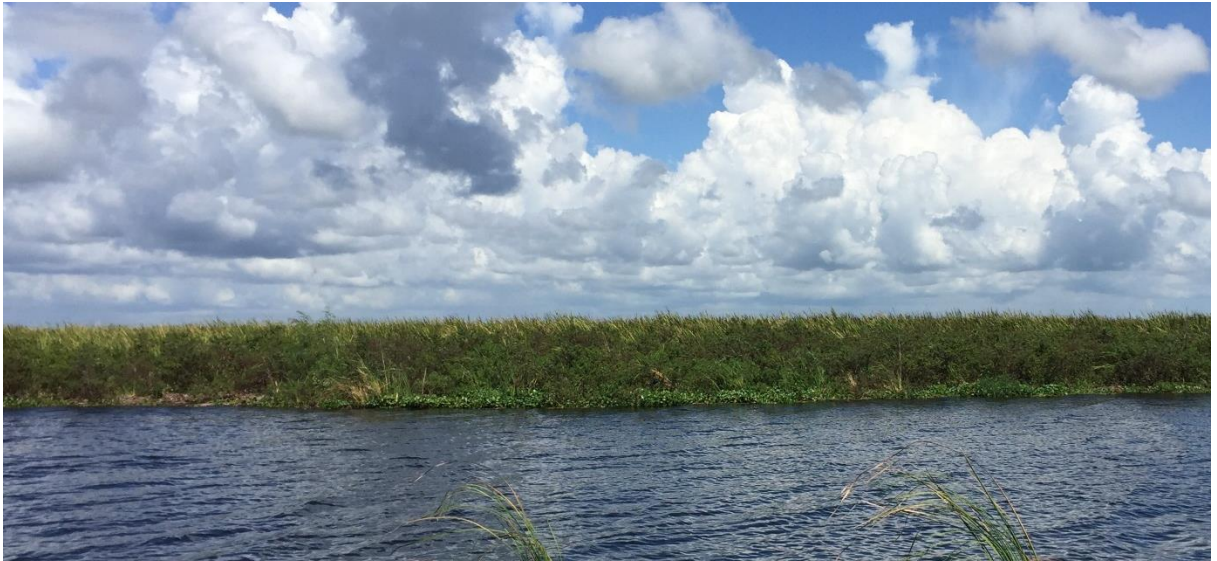
Facing north from Fisheating Bay into cattail wall.

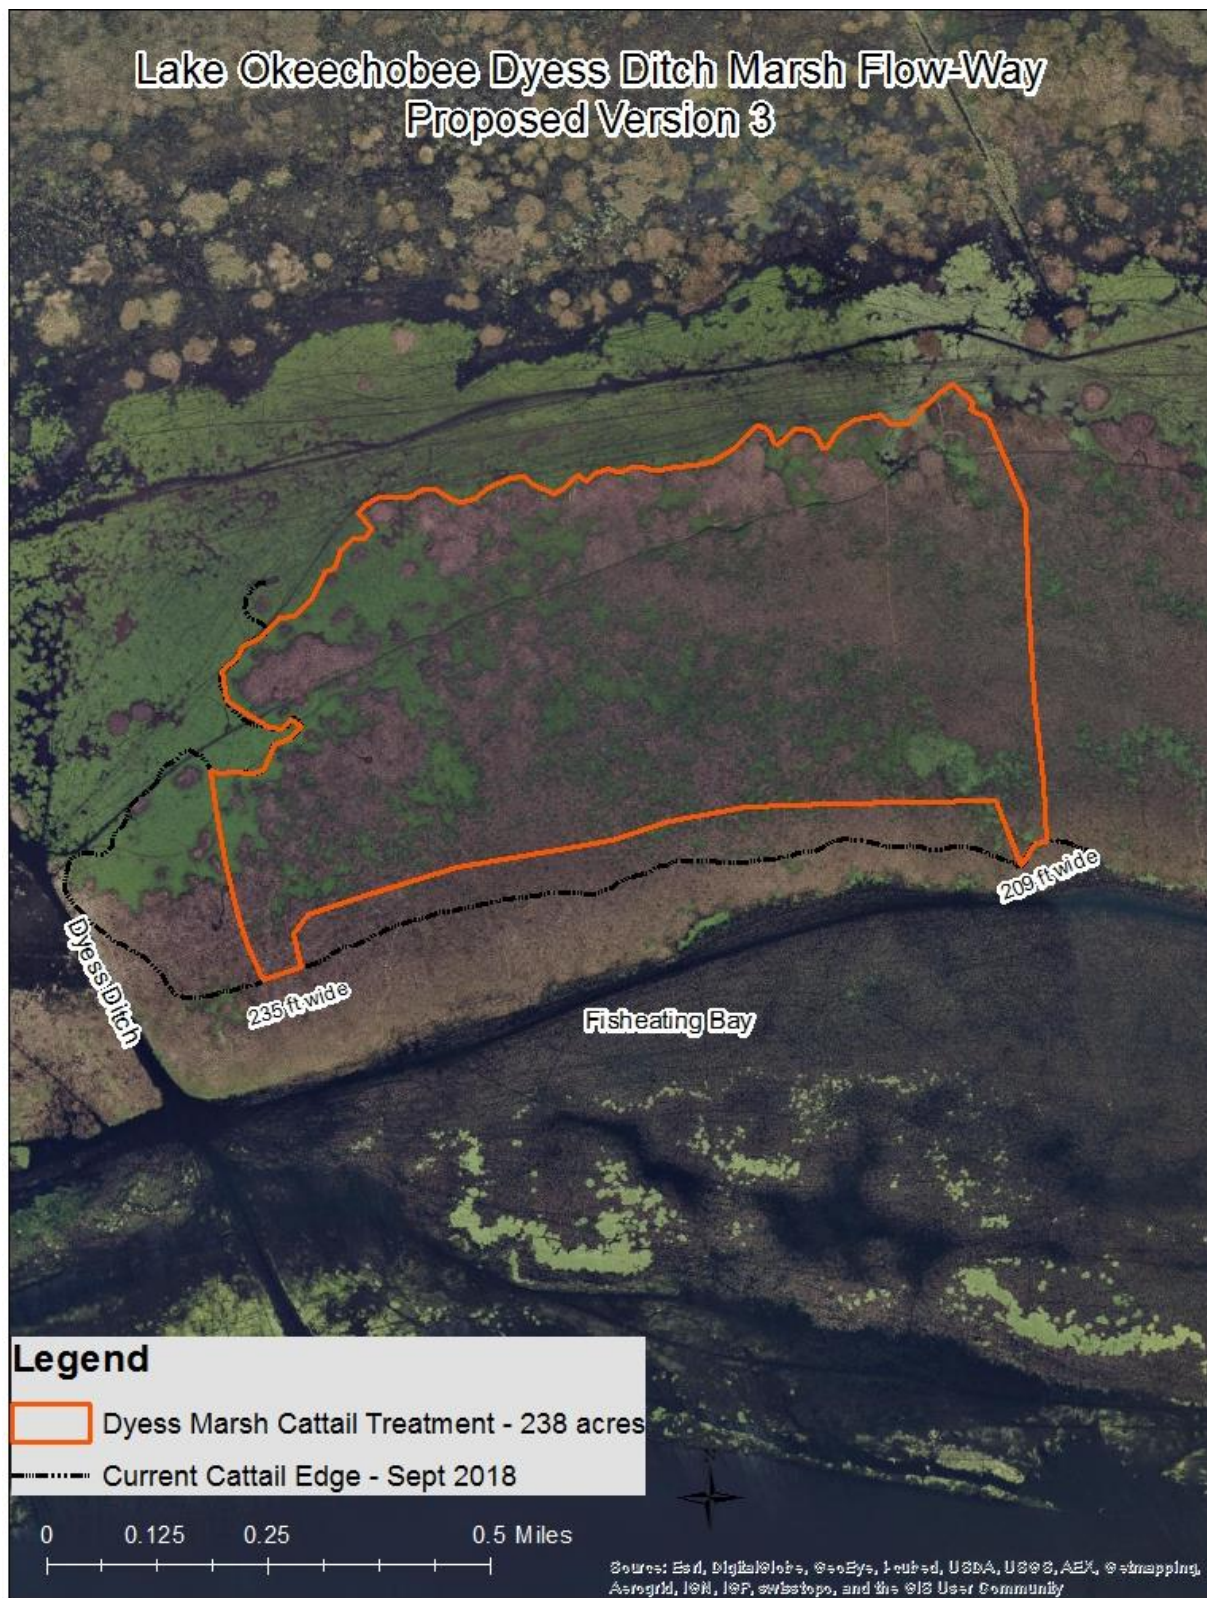
Figure 3 – Dyess Ditch Marsh 238 acre herbicide treatment area north of Fisheating Bay.

A 238 acre open water pocket will be created within the cattail that extends to the edge of the lilies and create two openings through the cattail to Fisheating Bay (Figure 3). This is expected to allow the circulation of some water through the newly opened area. Due to the size of the area, wind patterns are also expected to help circulate water. Water movement is expected to help move water within the lilies to the north. A 200-300 foot edge would still remain between Fisheating Bay and the newly opened area. During low water, having other species, such as spikerush or SAV, come up in these areas would be ideal. During higher water, clumps of cattail or bulrush may begin to create small patches within this opening. Anglers will be able to fish along the newly created edges, ducks will have an area to land adjacent to the lilies and snail kites are expected to nest in the cattail and forage in the new opening. Secretive marsh birds will still have many acres of cattail to the east of the newly created opening to use. Like other created openings on the lake, this area will be allowed to naturally fill in and go through various successional stages. This area may eventually be treated again in the future if cattail again becomes too thick.

1. Cattail will be treated with Clearcast at a rate of 32 oz/a via aerial application. Clearcast at these rates is fairly selective and should not kill any other species within the treatment area other than cattail. This 238 acre area will include a 235 foot opening to Fisheating Bay in the west and a 209 foot opening in the east.
2. At least 3 months after herbicide treatment of the cattail, once cattail has browned and fallen over, prescribed fire will be used to reduce the organic material falling to the bottom. Adjacent green cattail may also burn, allowing the clearing of dead thatch.
