Bone Lake Carp Barrier

Hybrid fish barrier design

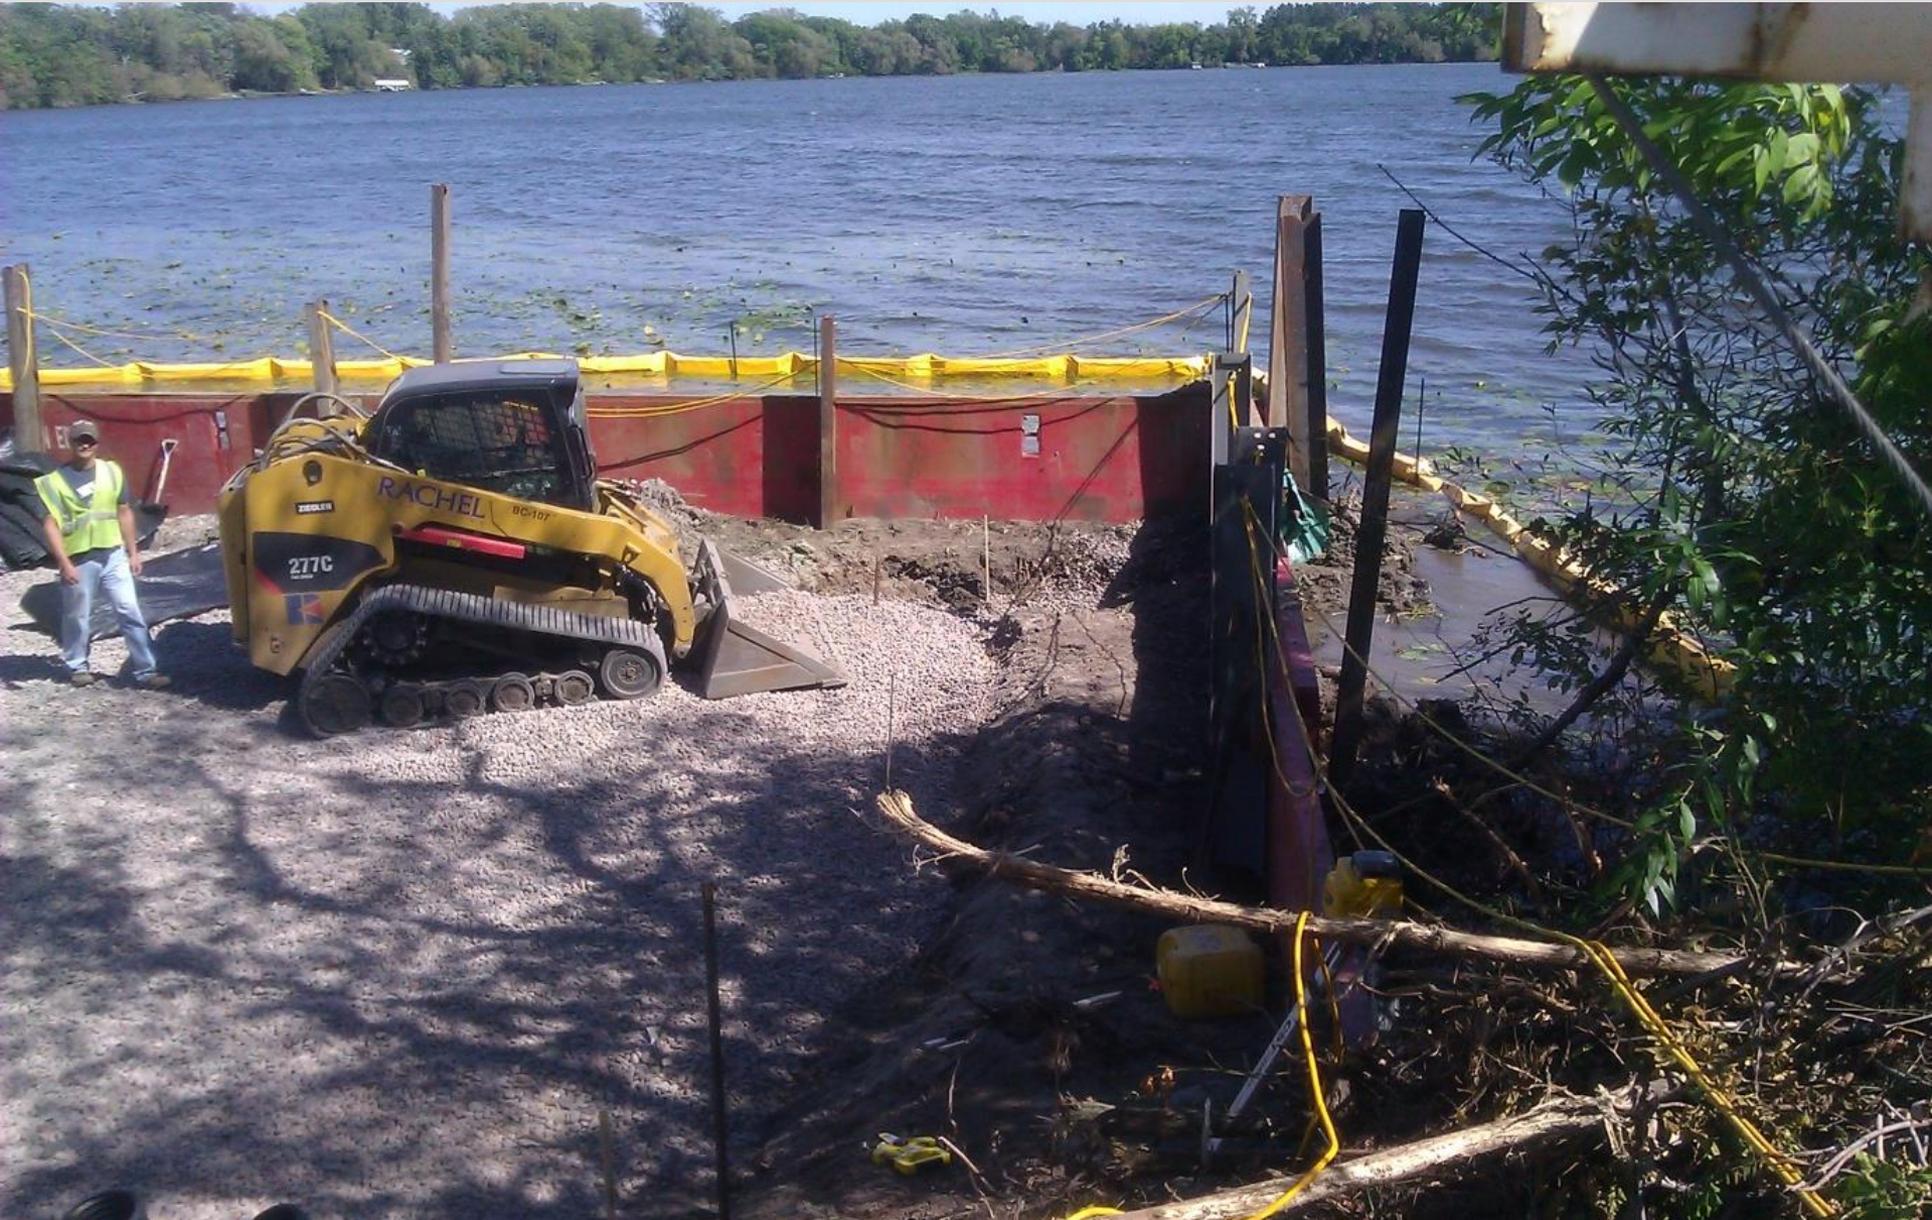
Construction of draintile bed

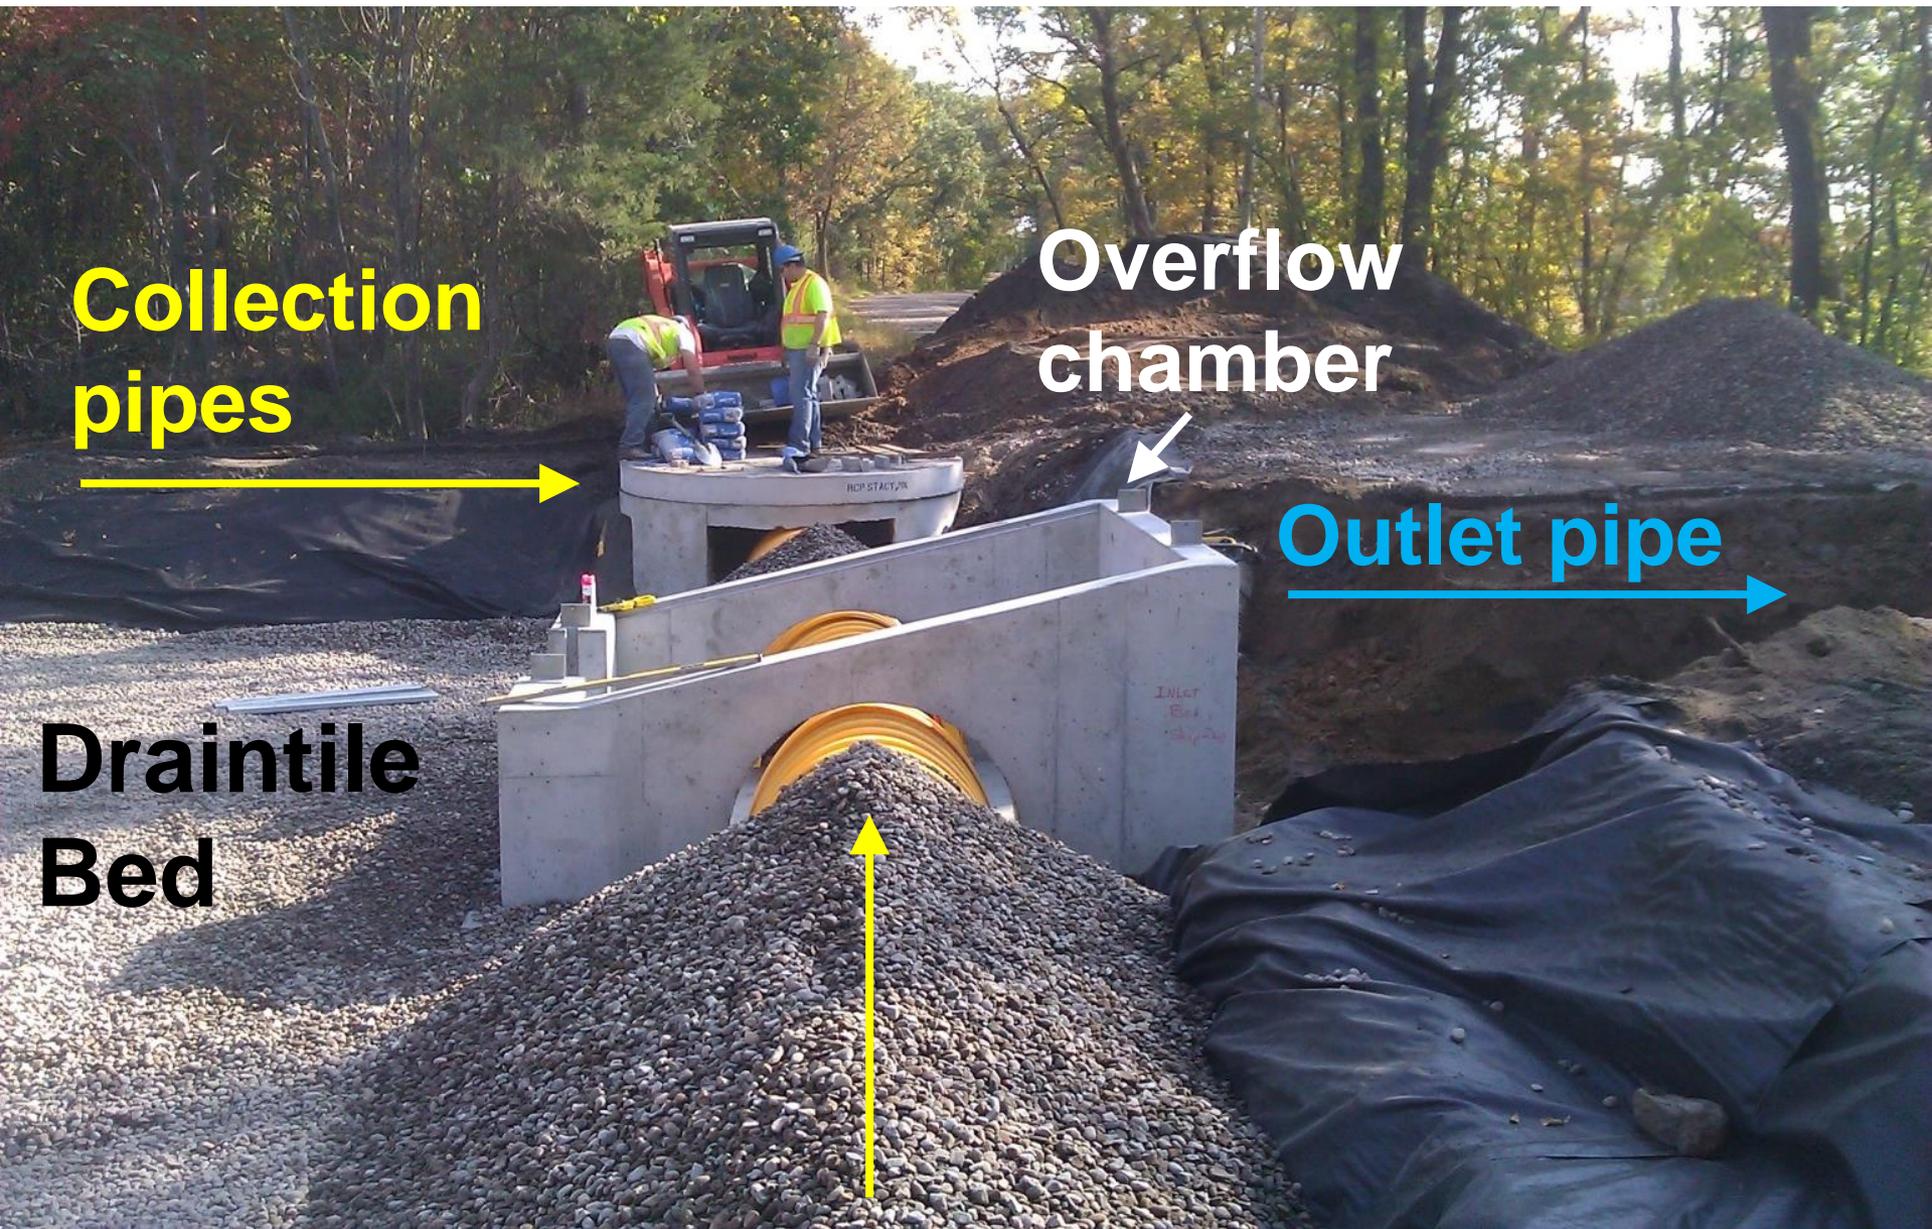
Construction of overflow chamber

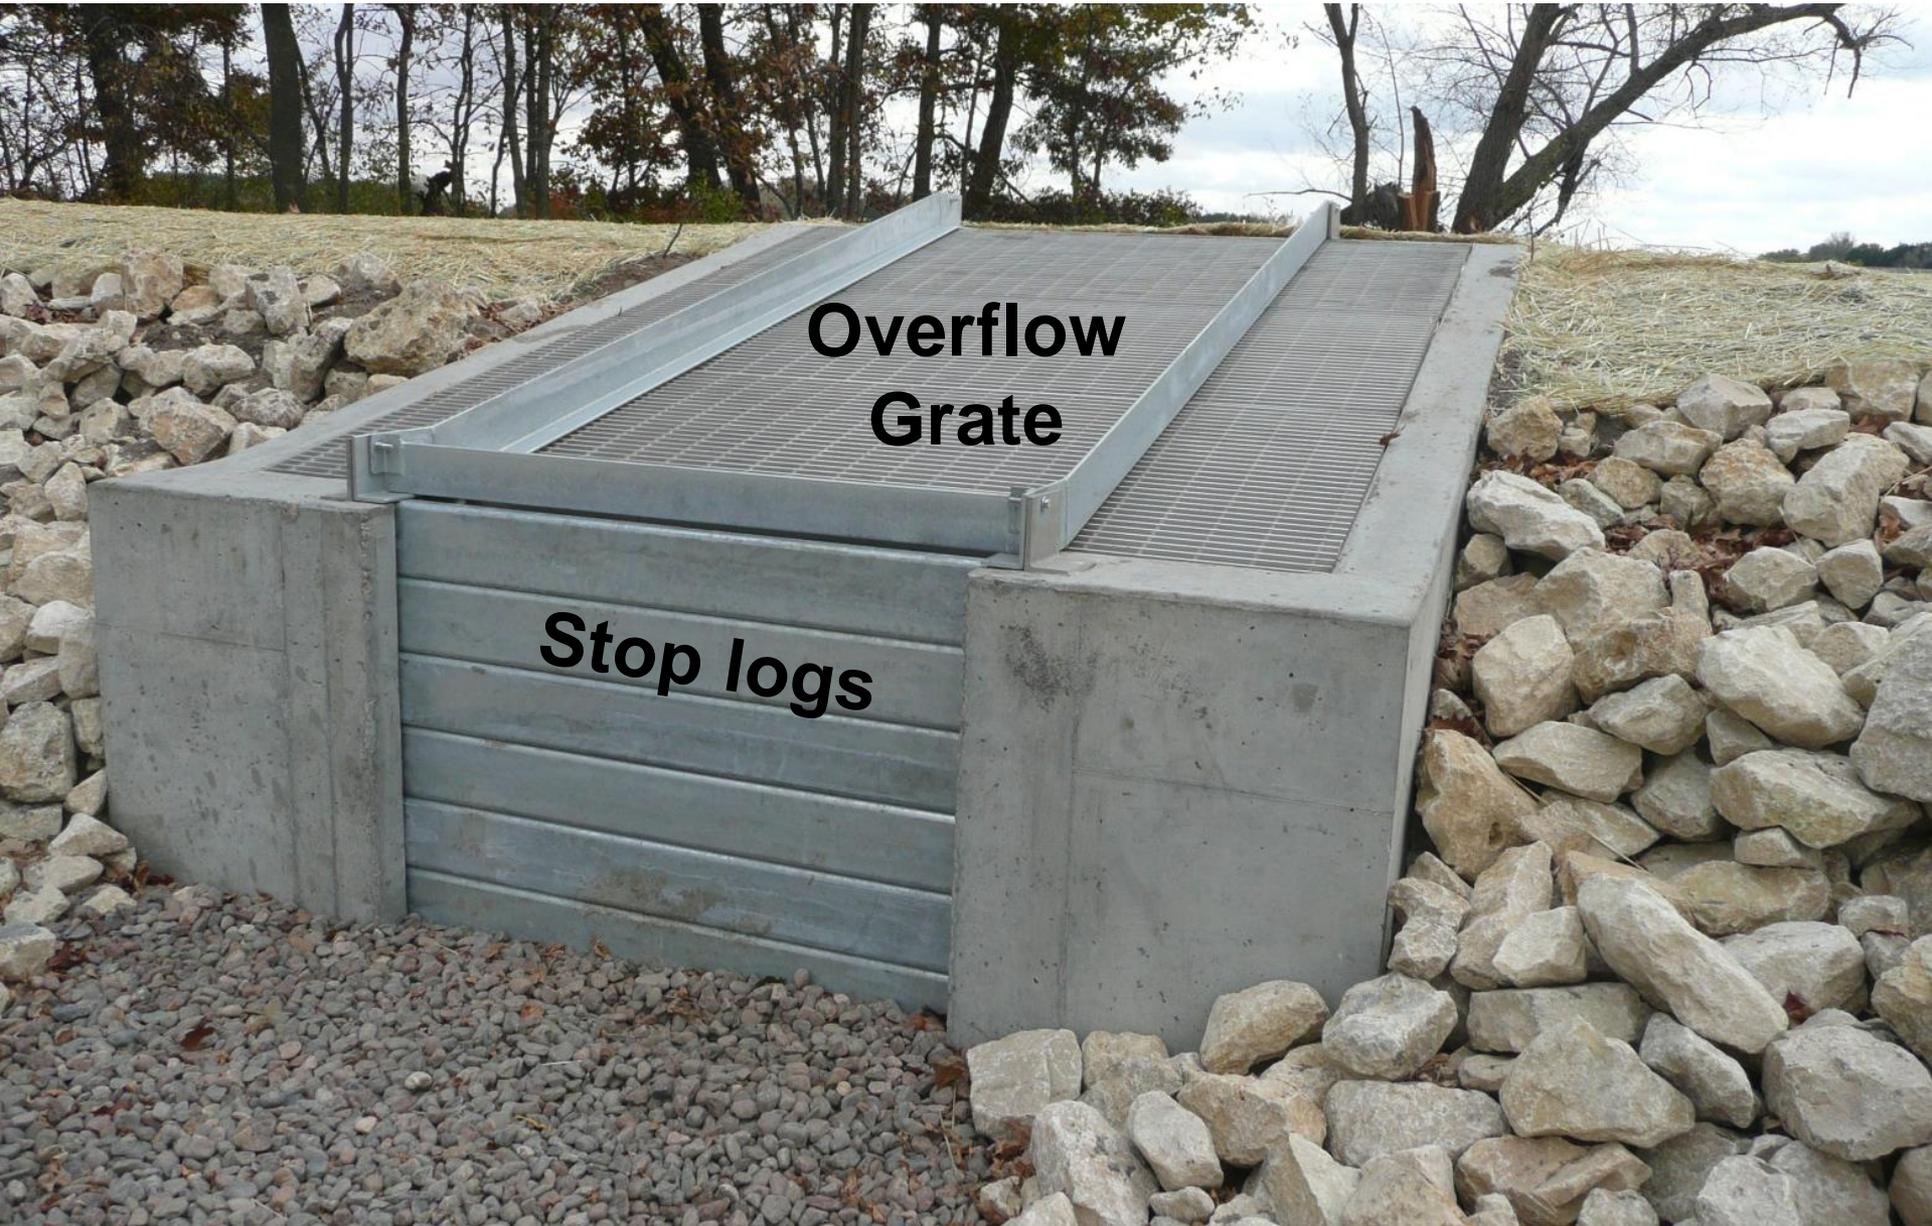
Overflow chamber

**Overflow
Grate**

Stop logs

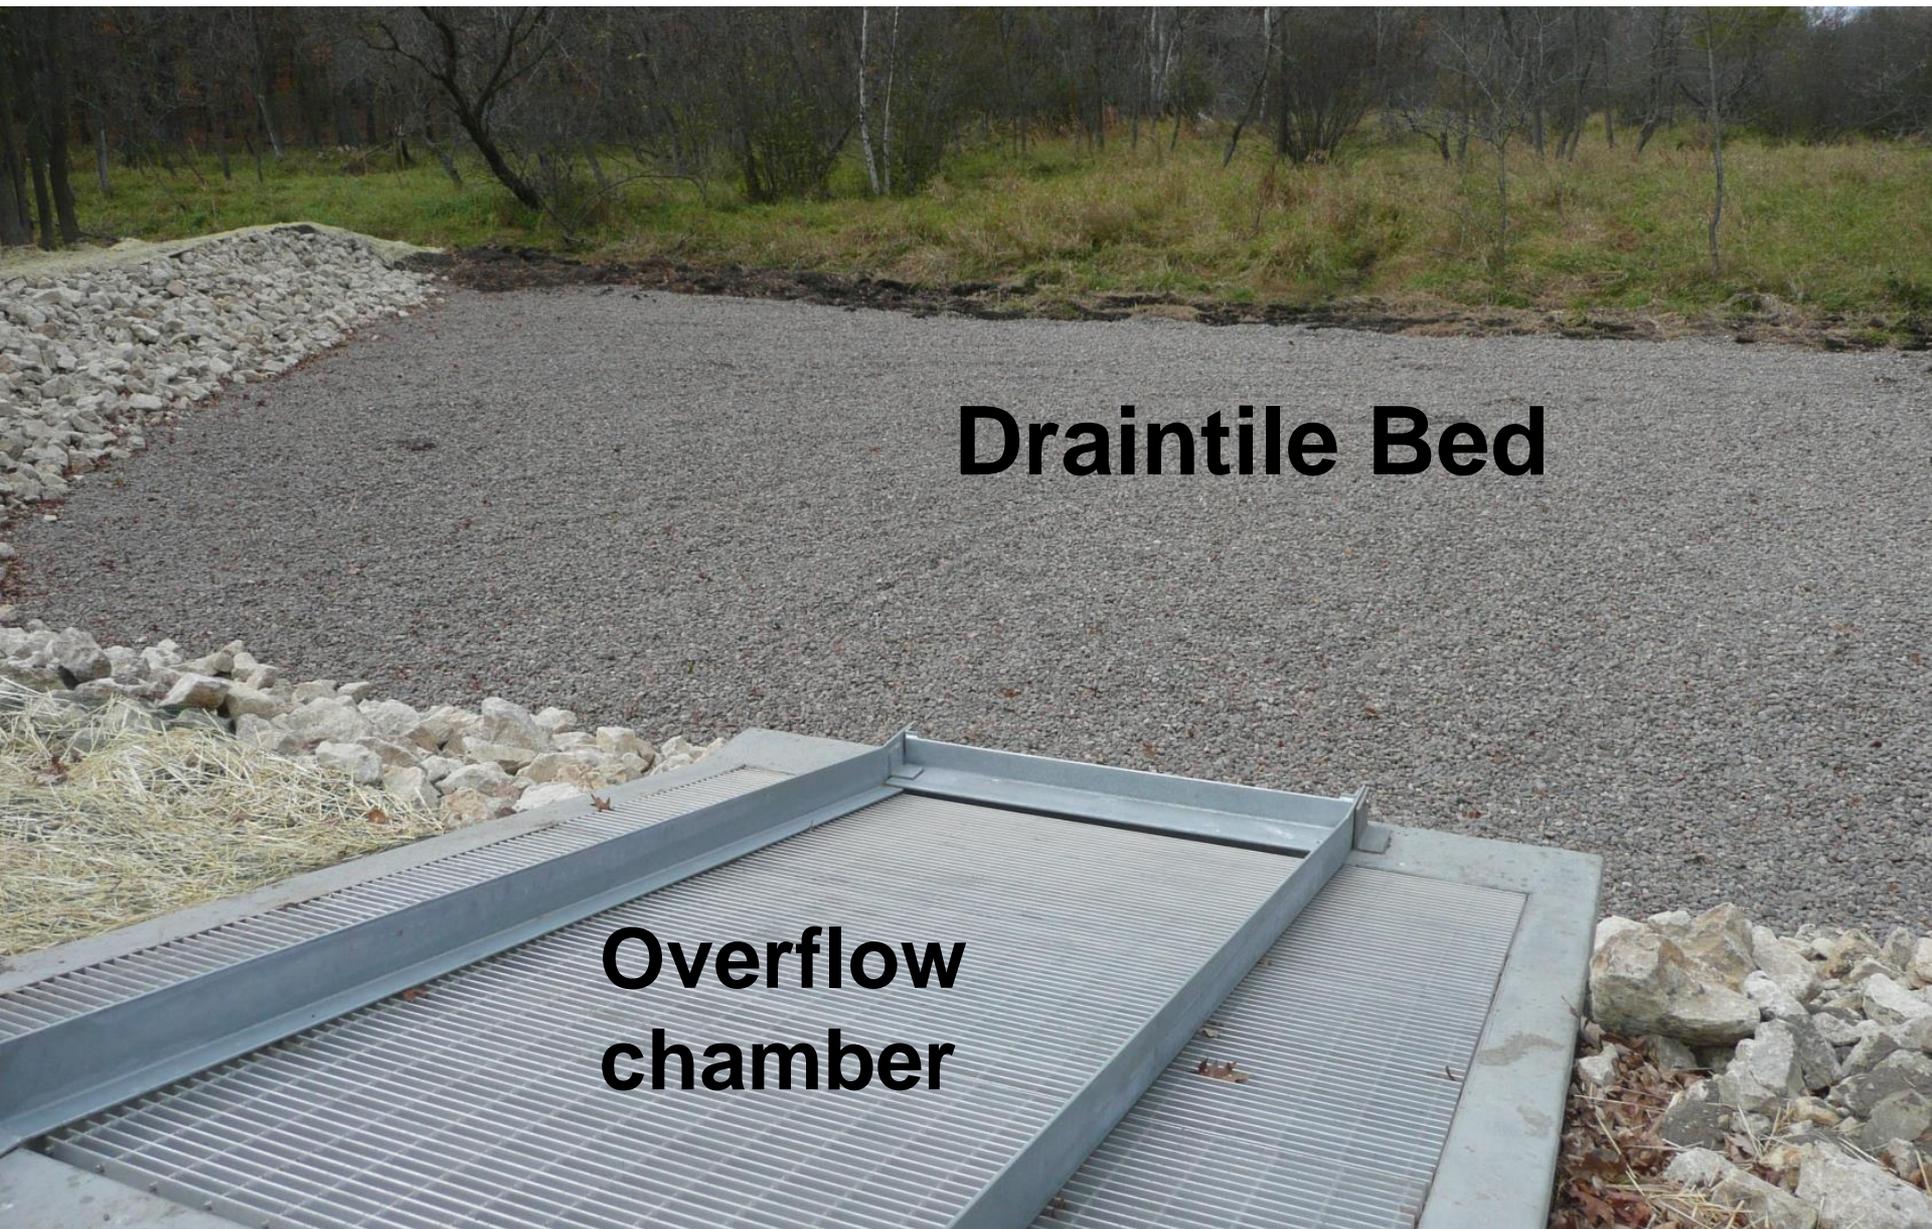
A photograph of a post-construction site. In the foreground, there is a rectangular metal overflow chamber with a grid-like grate. The chamber is set into a concrete base. Behind the chamber is a large, flat area covered in grey gravel, which is the drintile bed. To the left and right of the gravel area, there are piles of larger, light-colored rocks. The background shows a line of trees and some green grass, indicating a natural or semi-natural setting.

Drintile Bed

**Overflow
chamber**

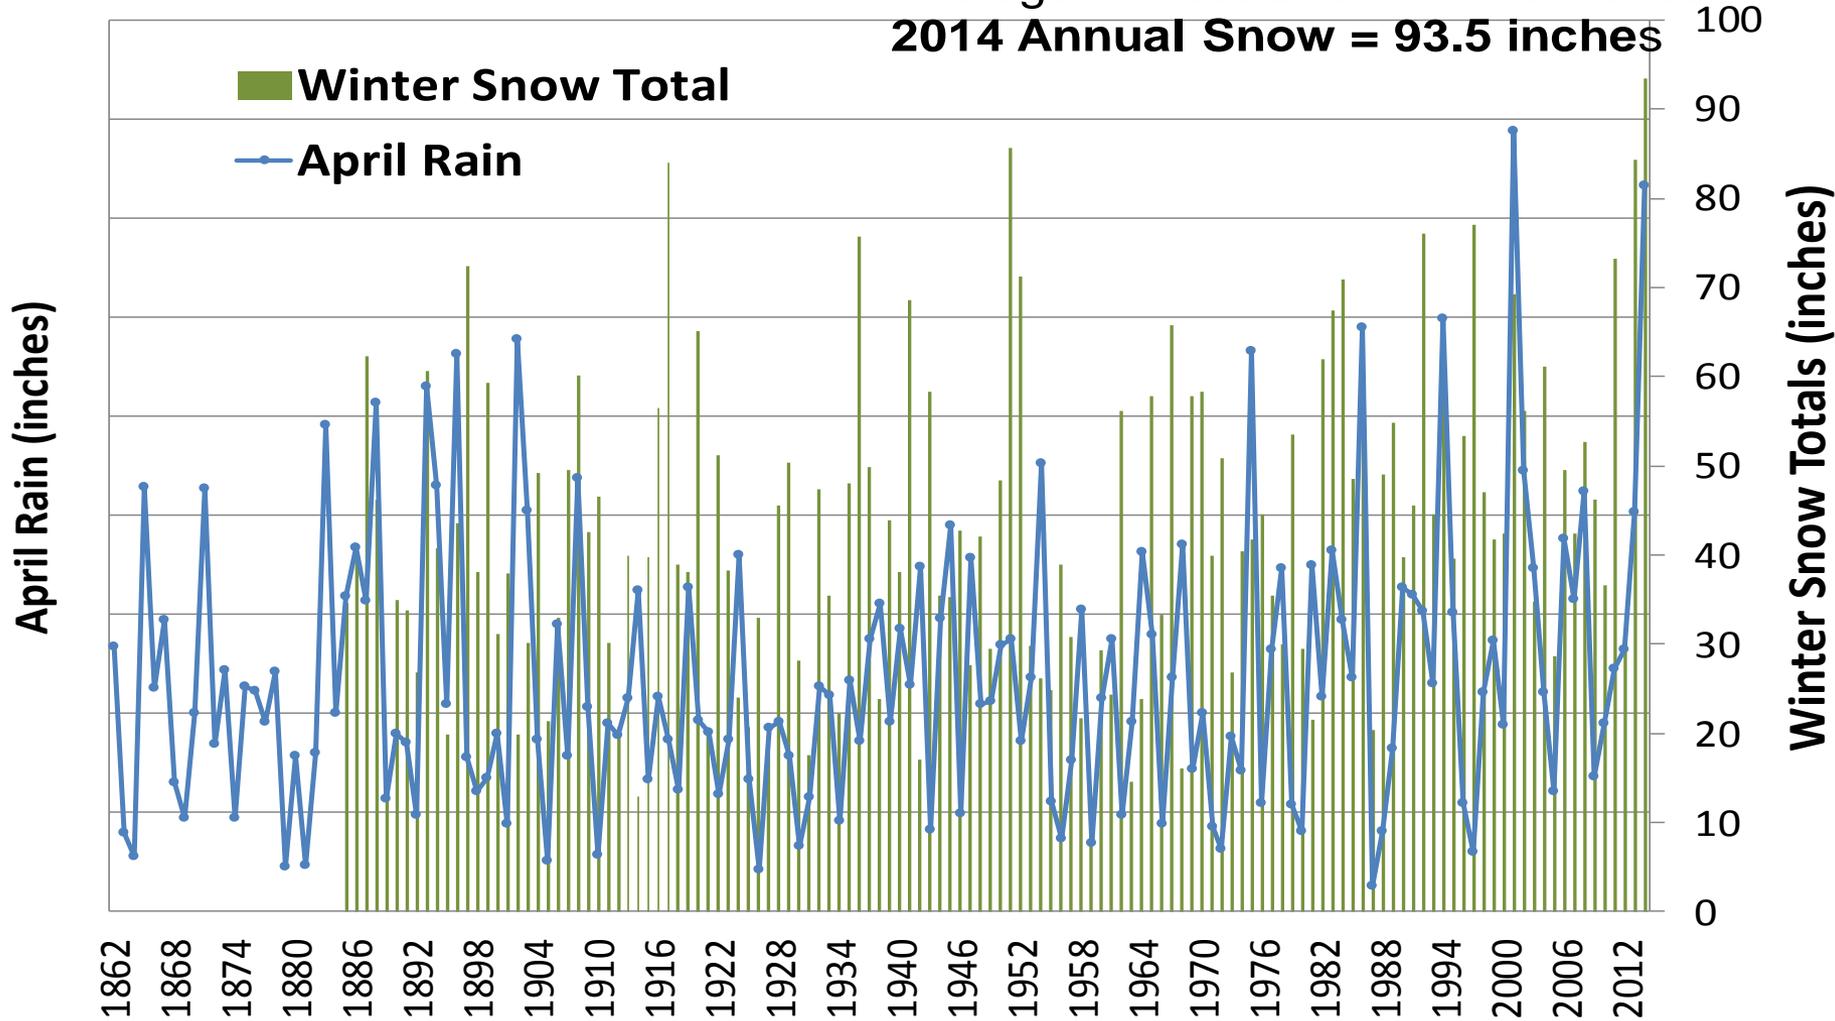
Forest Lake Precipitation Data

Average April Rain = 2.38 inches

2014 April Rain = 7.33 inches

Average Annual Snow = 42.8 inches

2014 Annual Snow = 93.5 inches

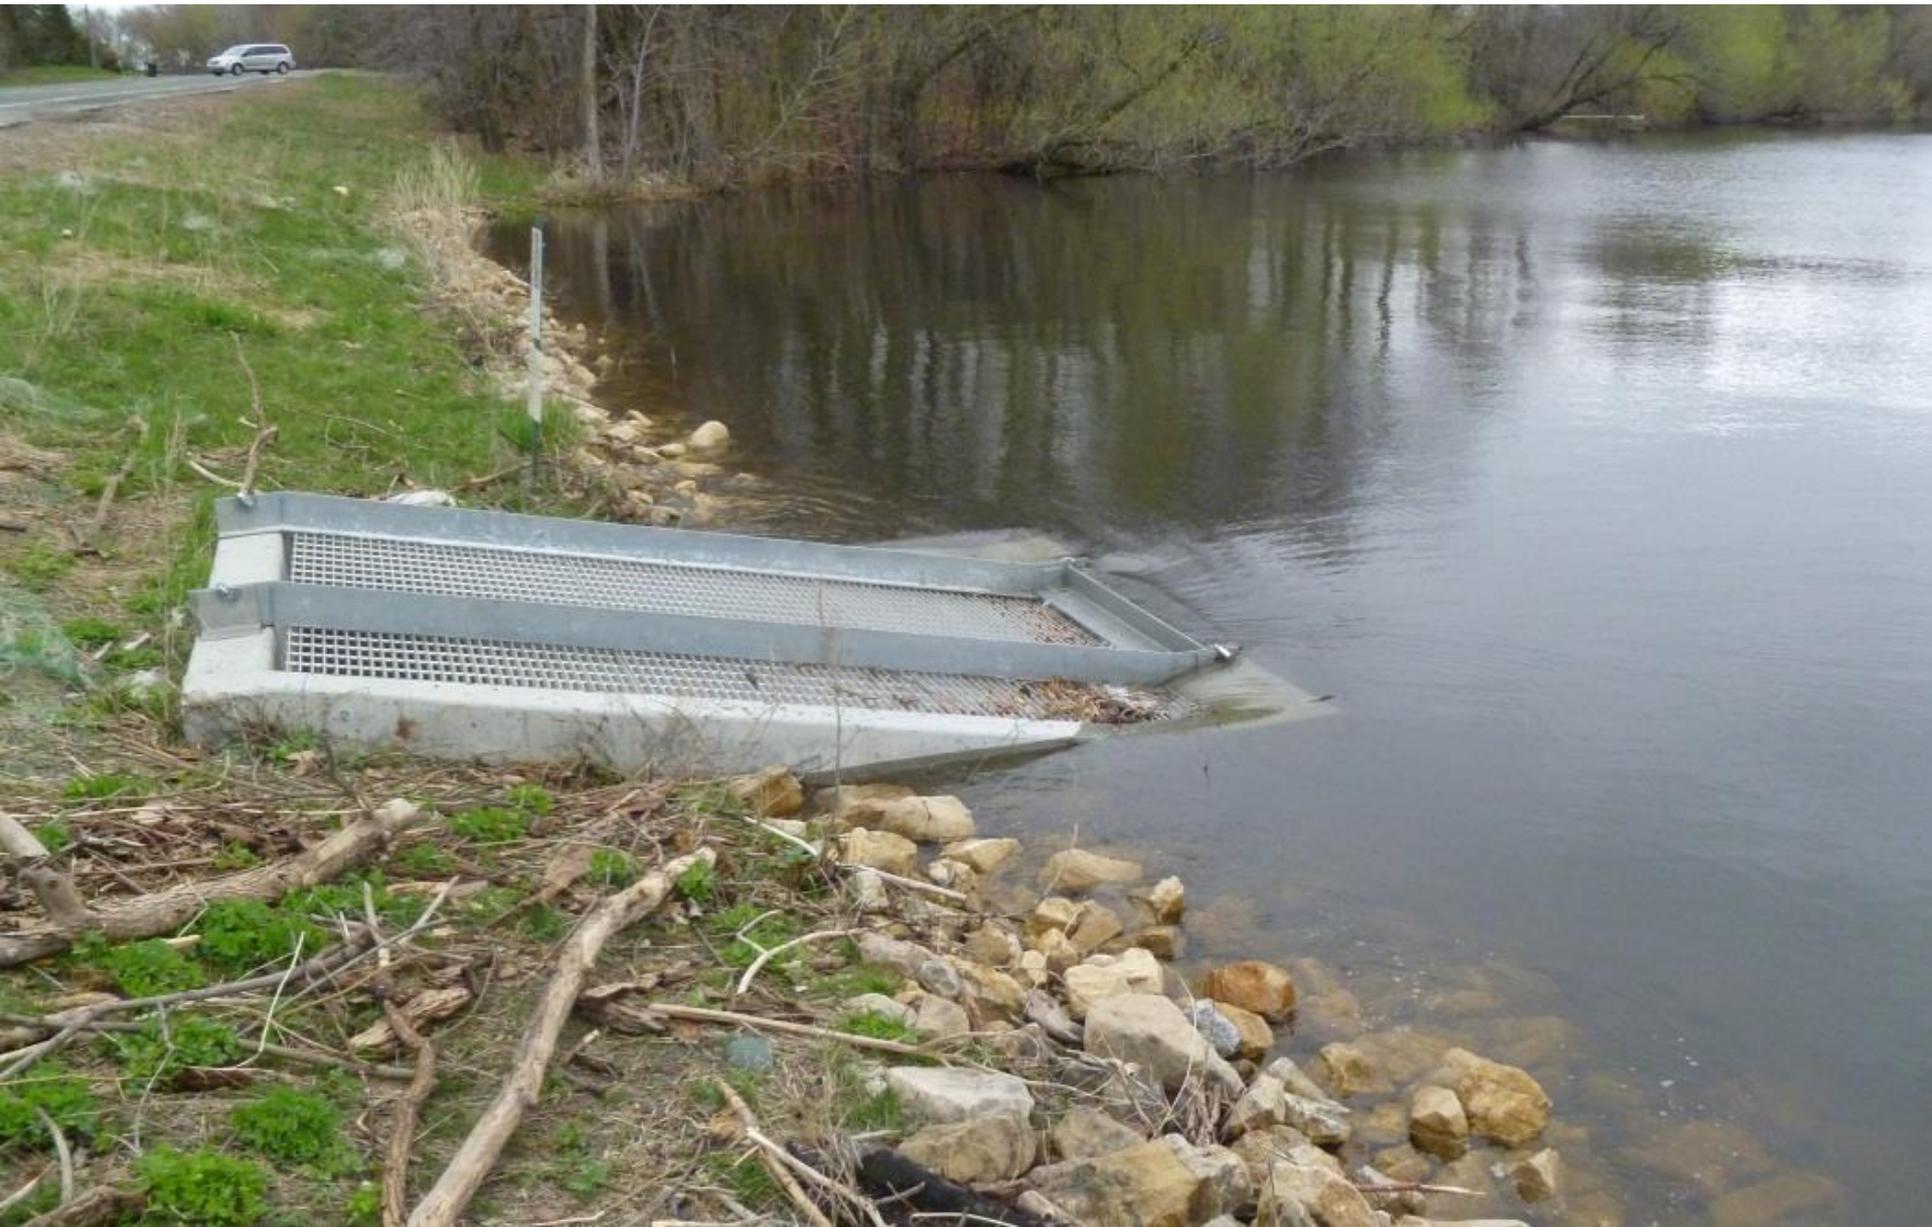
Levels exceed overflow in May 2014

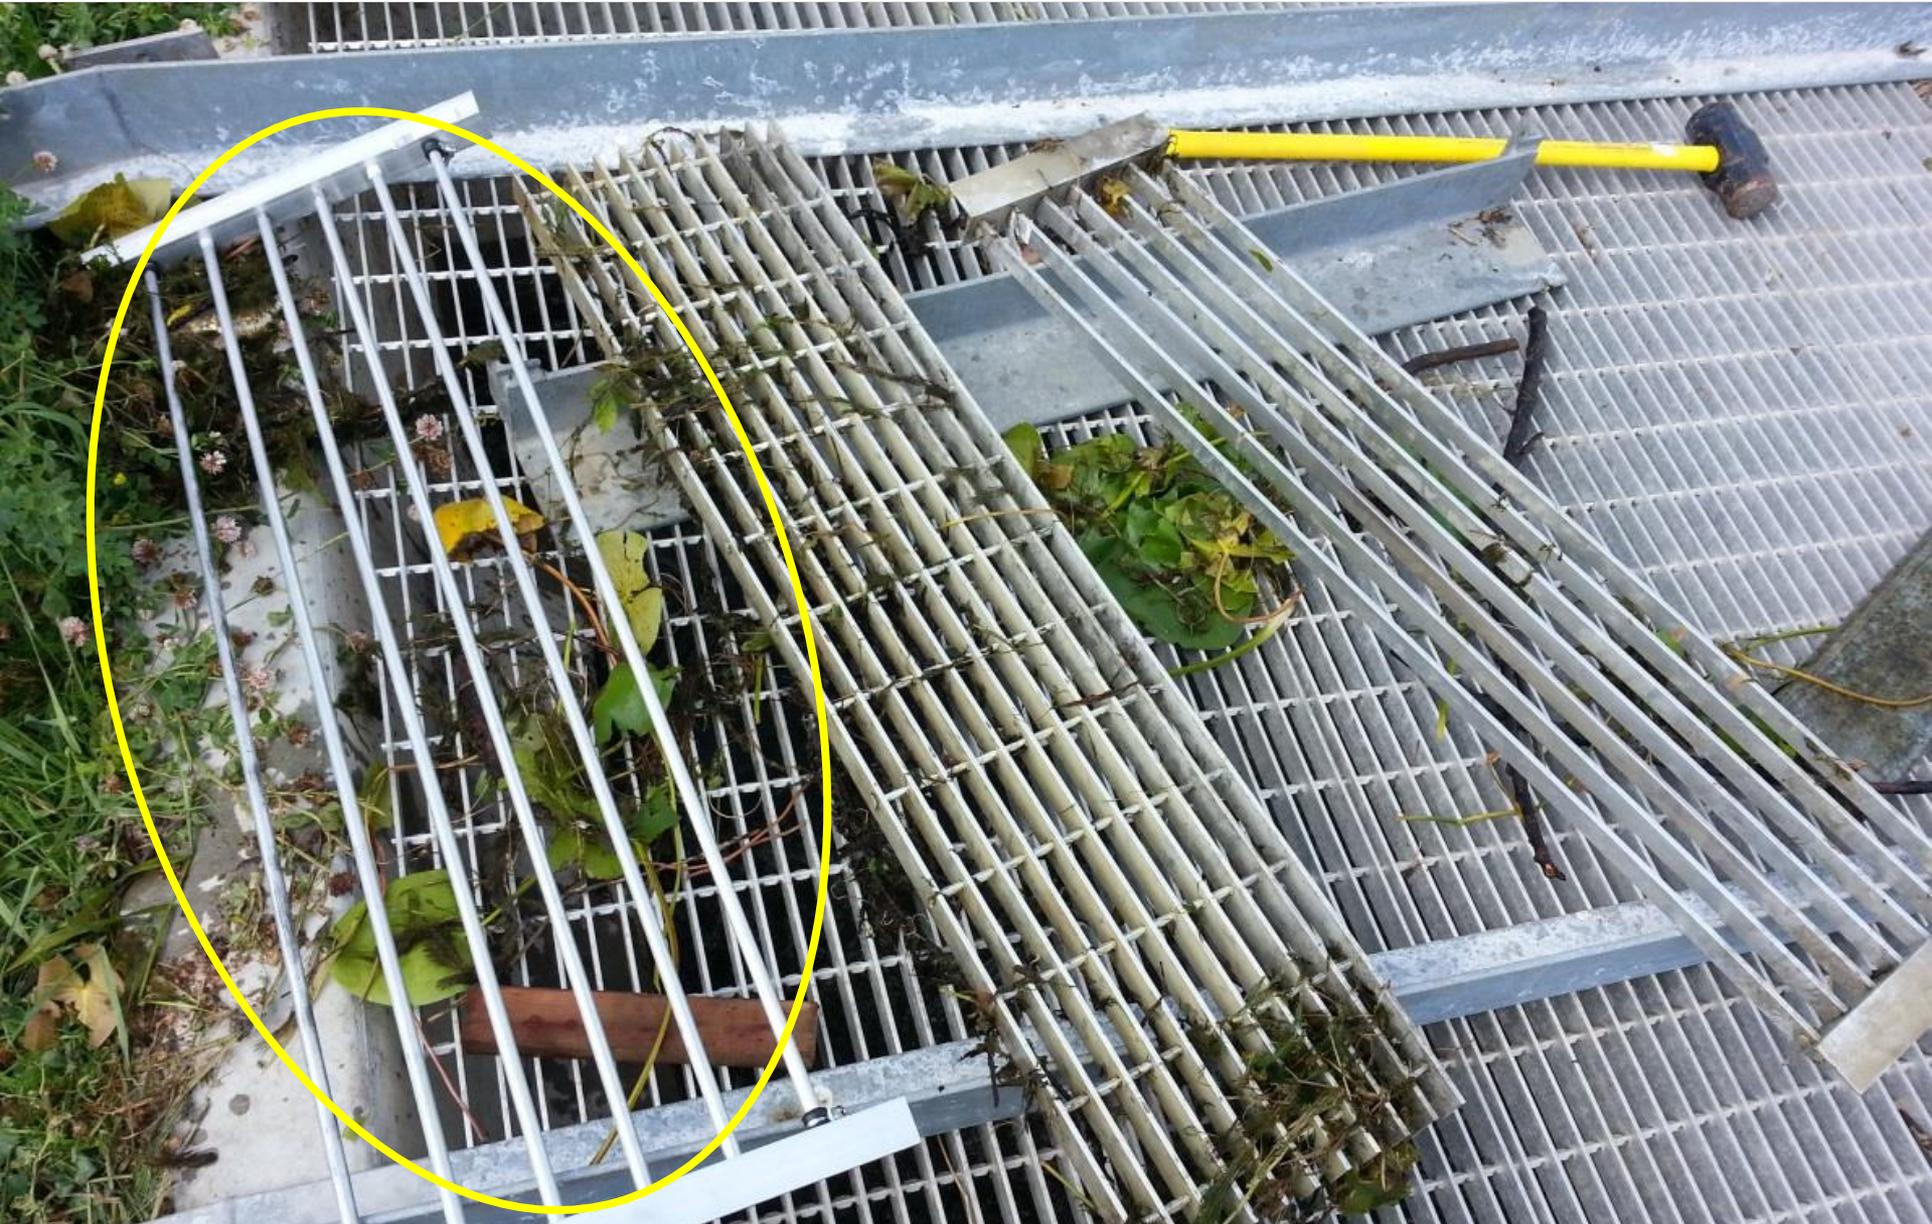
Grates clogged with aquatic plants

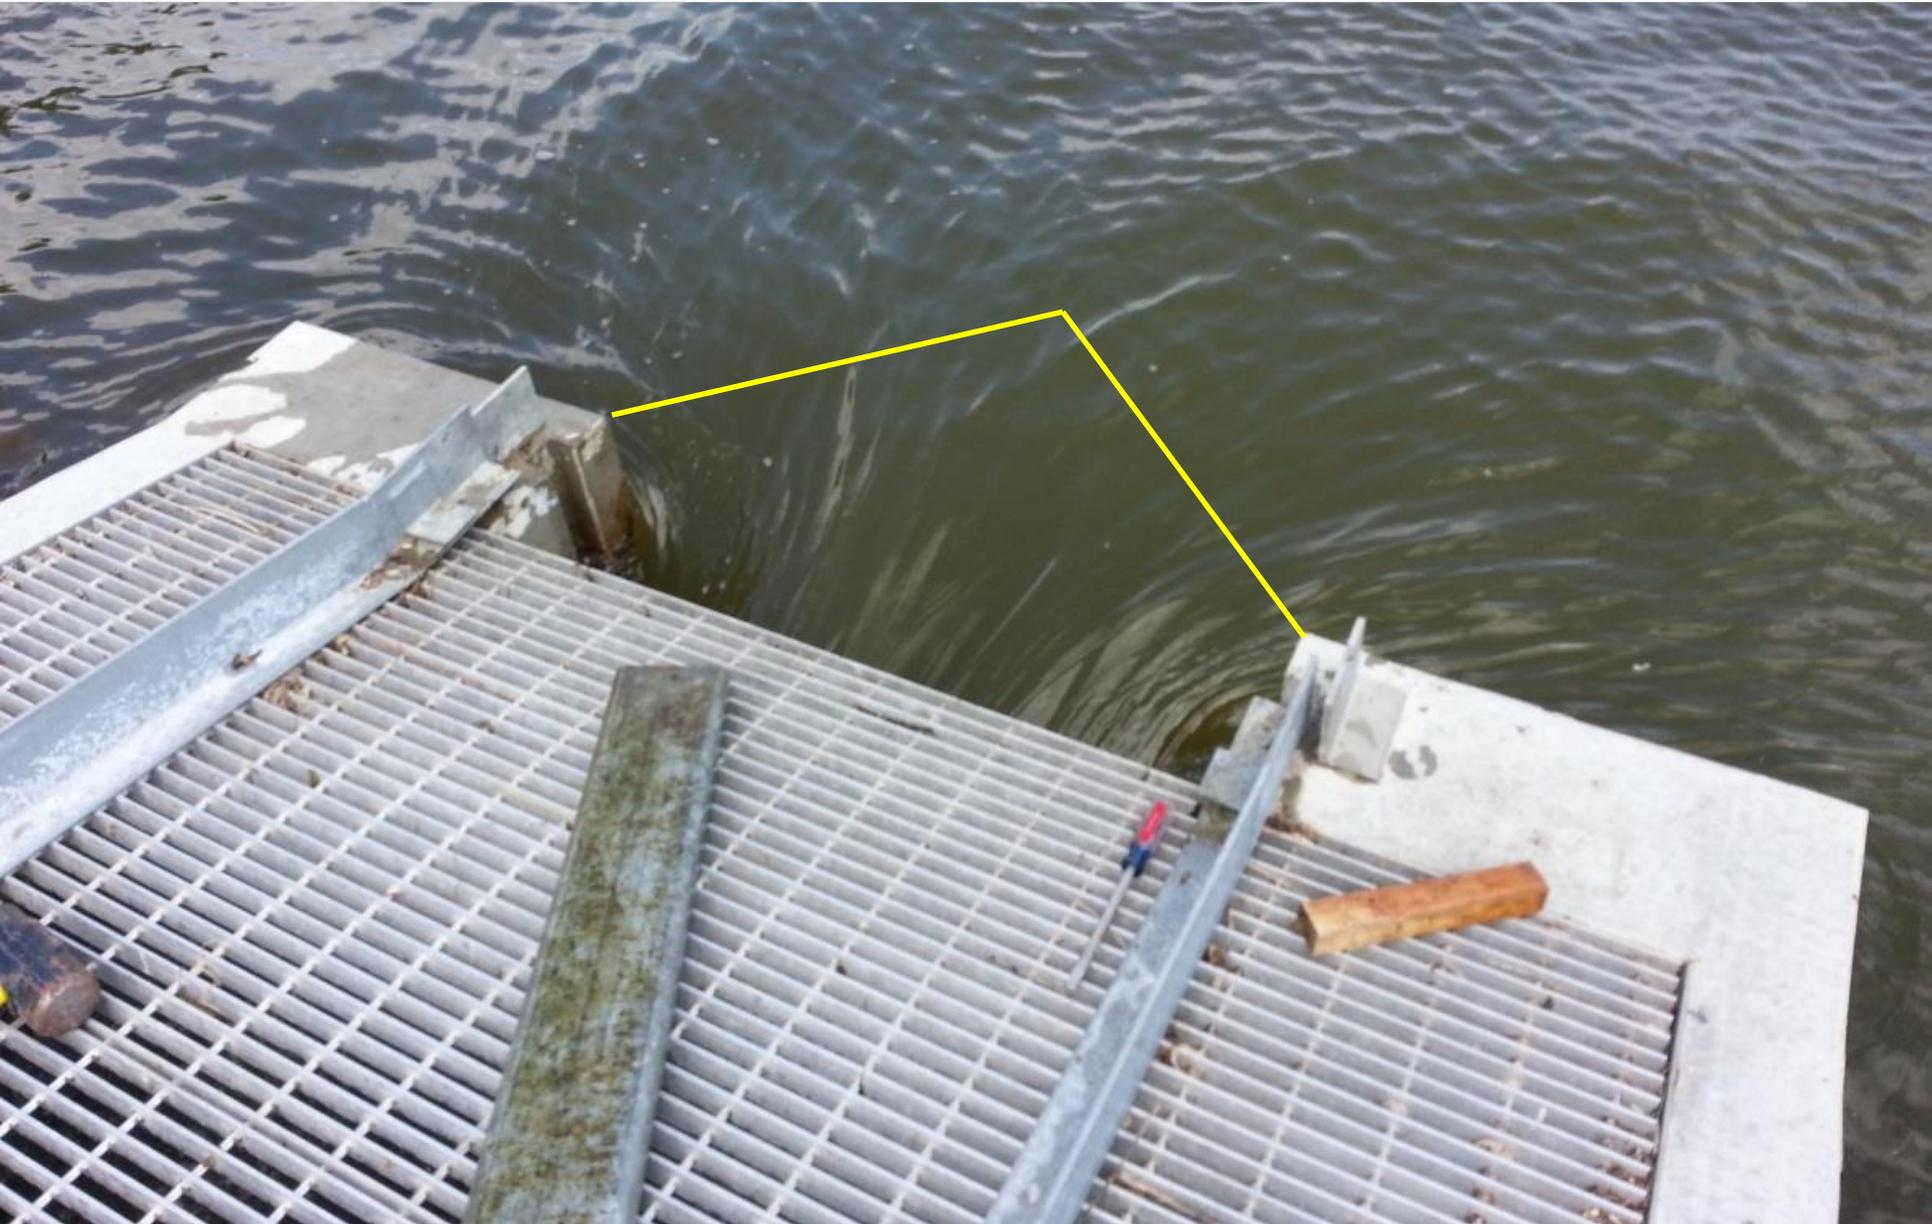
High flow trapped turtles against grate
